Technology Transfer in Computing Systems

D3.49: Individual TTP49 abstract

TETRACOM no. 49: Computer Vision Station Prototype for Biscuit Tiles Quality Control

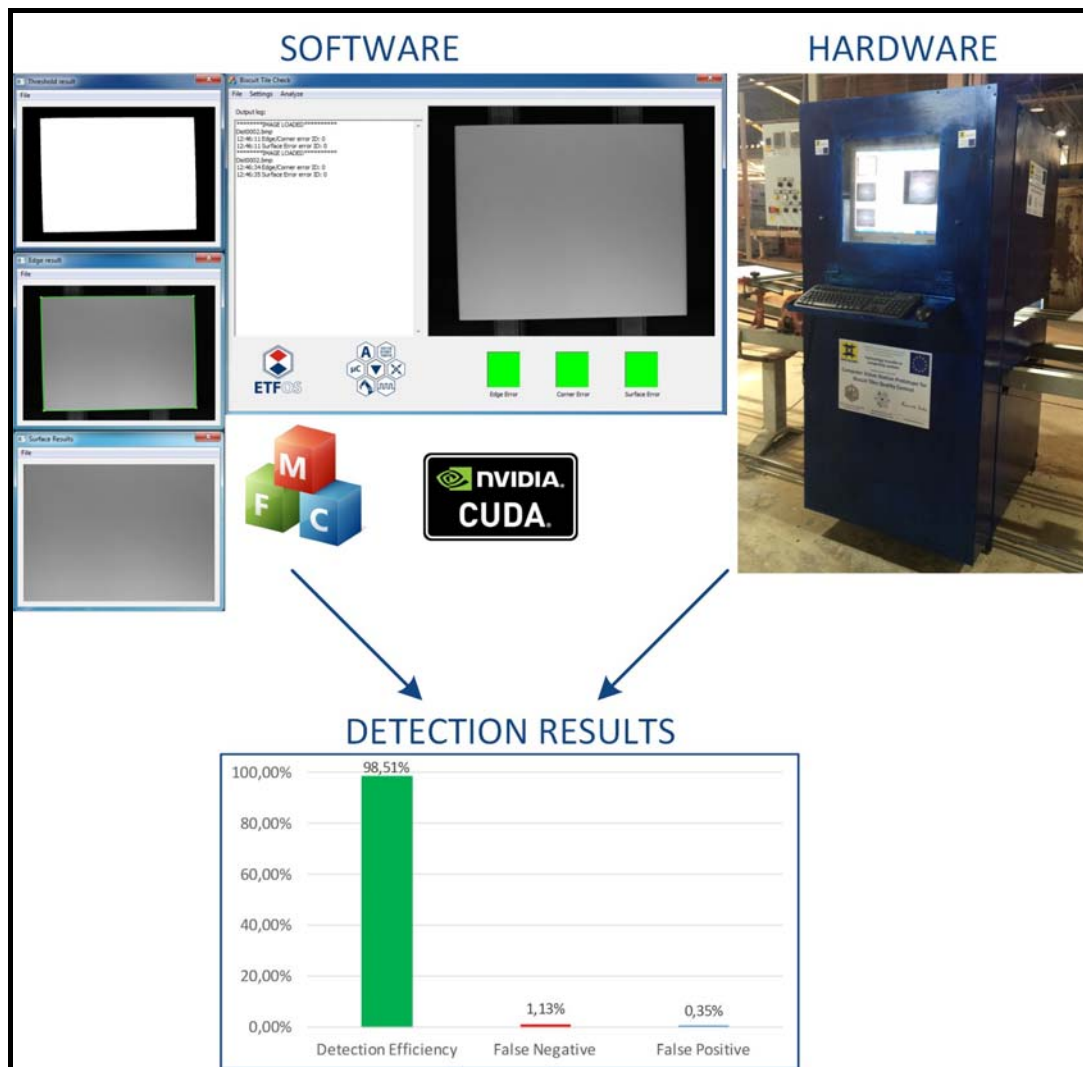
The CVS consists of metal housing, shown in the figure above, mounted on the conveyor line. Metal housing has several fans mounted on the top for air filtering and dust removal. LED light system, area-scan camera, parallel processing unit, digital I/O interface and tile proximity sensor are built in inside the housing. LED light system is controlled by a custom made control board with the developed application. Proximity light sensor marks the start of the tile image acquisition. Area-scan camera acquires the tile image and sends it via USB 3.0 interface to the parallel processing unit. Parallel processing unit executes all image processing algorithms and informs the user using built in LCD monitor and buzzer. The unit is based on core i7 CPU and Nvidia GTX 960 GPU.

The user-friendly MFC (Microsoft Foundation Class) based GUI application is created (main windows of the application are shown in the figure above). The developed application communicates with the LED control system, area-scan camera and digital I/O interface. All developed algorithms are implemented in C++ language using OpenCV and Nvidia CUDA libraries. Image processing is executed in several stages: image acquisition and distortion correction, image thresholding, edge defects detection, corner defects detection, surface defects detection and results displays. Tiles are classified as correct (no defects) or defected (have edge, corner or surface defects). The algorithms are implemented using sequential execution and parallel execution with windows threads and Nvidia CUDA.

Preliminary results show the maximum execution time below 900 ms that satisfies defined real-time requirements. The defect detection results, shown in the figure above, are promising. In the depicted graph less than 2% of biscuit tiles with defects are classified as non-defected, less than 0.5% tiles with no defects are classified as defected, while more than 98% are correctly classified. Possible savings in costs are at minimum 40.000 € per one production line, as estimated by the company.
